# An Investigation into Protection Integrity of Distribution Transformers - A Case Study

**Abstract**—This paper investigates protection integrity of distribution transformers in Ghana. The purpose of the study was to find the main causes of distribution transformer failures in Ghana. The study was conducted in the Ashanti East Region, one of the operational areas of Electricity Company of Ghana ECG with high incidence of distribution transformer burnouts. Data on status of protection systems on 676 distribution transformer stations were taken and analyzed. It was found that protection integrity at distribution substation is riddled by indiscriminate use of copper links to replace blown HRC fuses and high ground resistance. The study clarifies why distribution transformers with lower power ratings are more vulnerable to abuse of protection systems than distribution transformers with higher rated powers. The paper reports on the investigation and proposes alternative solutions in mitigating the problem. Although the background work of the study is restricted to Ghana, the applicability and importance of the work would be useful to the scientific community.

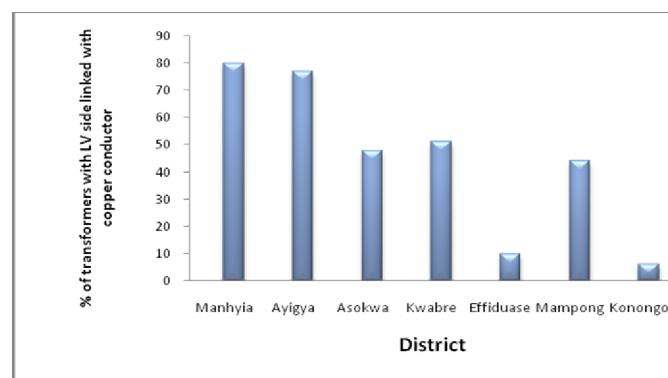
indiscriminately fused with copper links. The general expectation is that such abuse of protection integrity should rather result in high failure rate. Unfortunately, the situation is on the contrary.

Fig-4: Transformer with LV side fused with copper links

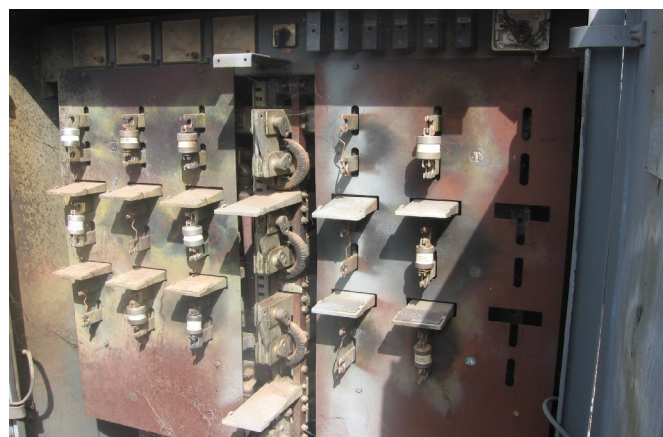
Fig-7: Copper links used as Fuses

The effect of the copper links was rather seen on the distribution pillars, see Fig-7. Districts with high incidence of LV copper links as fuses recorded high incidence of DP burnouts- the links were directly hooked to fuse contacts in the DPs. As a result, the DPs and their associated instruments were exposed to naked fire of the copper links during fusing. Mampong was also high on copper links but with no DP burnout because wedge type fuses (aerial fuses) were predominately used in the district.

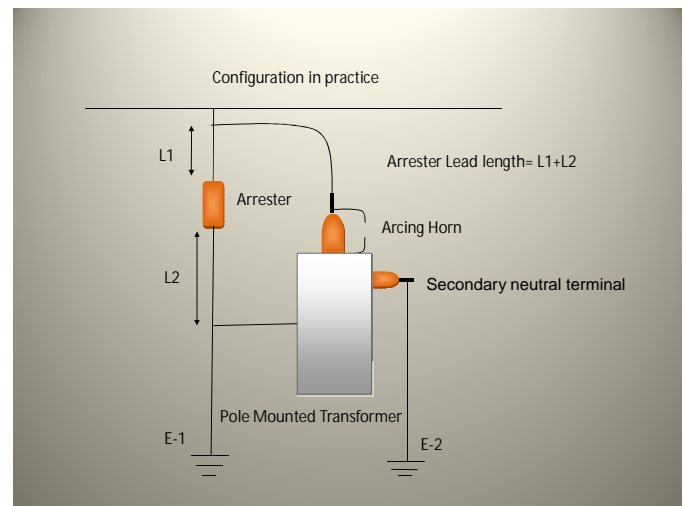
The lightning arrester circuitry was found to be standardized for all the 676 distribution substations visited, see Fig-10. Arrester's lead length was found to be approximately 7 meters. We considered this too long for effective protection of the transformers. Arrester selected for an equipment protection must have a discharge voltage lower than the BIL of the equipment. For example, surge arrester with a discharge voltage of 43kV is considered adequate for a protection of 75-kV BIL transformers. This arrester provides 74% protective level on transformers.

Fig-10: Lightning arrester lead length

the arrester discharge voltage. This is conservative for a standard 10-kA (8/20 $\mu$ s) wave parameter. Using a 7 m. lead wire and 8/20  $\mu$ s, 10 kA surge parameter, voltage drop across the arrester lead length would be equal to 11.48 kV, reducing the protective level to 36%. It is known that during arrester discharge, some amount of the surge voltage is let-through the transformer. This voltage, though considered harmless, could be destructive in a repetitive surge environment. A transformer with low arrester protective level could be expected to fail when subjected to repetitive surge incidence. To optimize protection level of surge arrester, the arrester should be installed directly across the terminals of the equipment to be protected, refer to Fig-11. Arrester lead length of 0.6m is recommended.

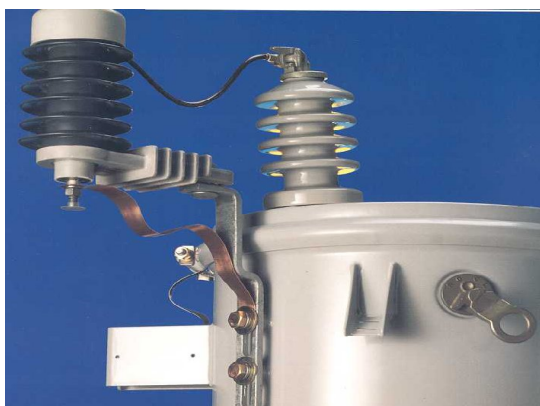
Fig-11: Recommended lightning arrester circuitry
