Investigating Damaged Capacitor Bank at a Quarry Processing Plant

Abstract— This paper investigates capacitor bank failure at a quarry processing company in Ghana. The company had blamed the Electricity Company of Ghana (ECG) for the cause of the damage. According to the company, the damage was due to frequent power fluctuations and outages experienced from the ECG distribution network. Analysis of the failure, using the EMTP RV, links the failure to harmonic resonance emanating from the company's power system. The paper presents and discusses techniques applied to investigate the problem and reports the results achieved. For safe and reliable operation of capacitor banks, it is recommended that harmonic content of an electrical installation is measured, analyzed and a good engineering judgment made before installation.

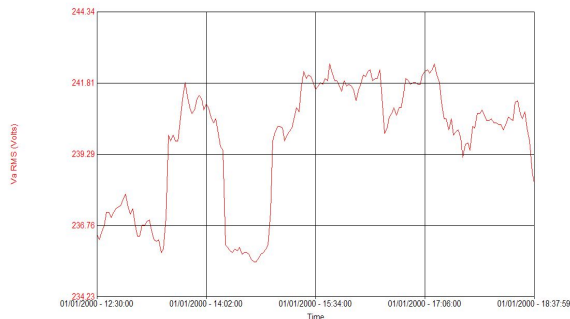
Fig.2: Voltage envelope as measured b the power analyze

Voltage limits are based on overall permissible voltage range allowable under standards. ECG operating voltage (in low voltage network) ranges from a maximum of 253V to a minimum of 207V. This is based on a nominal voltage of 230V representing $\pm 10\%$. Fig.2 shows voltage envelope as measured by the analyzer. Operating voltage range of 235 to 242V was recorded. This represents a voltage variation of 2-5% in comparison to ECG nominal voltage. The variation was therefore within the acceptable operating voltage limits.

From Fig.3, frequency variation of about 0.5% was noted. Effect of this variation reflected as 2% voltage sag in Fig.2. The 2% voltage variation was within the tolerable and acceptable ECG operating voltage limit.

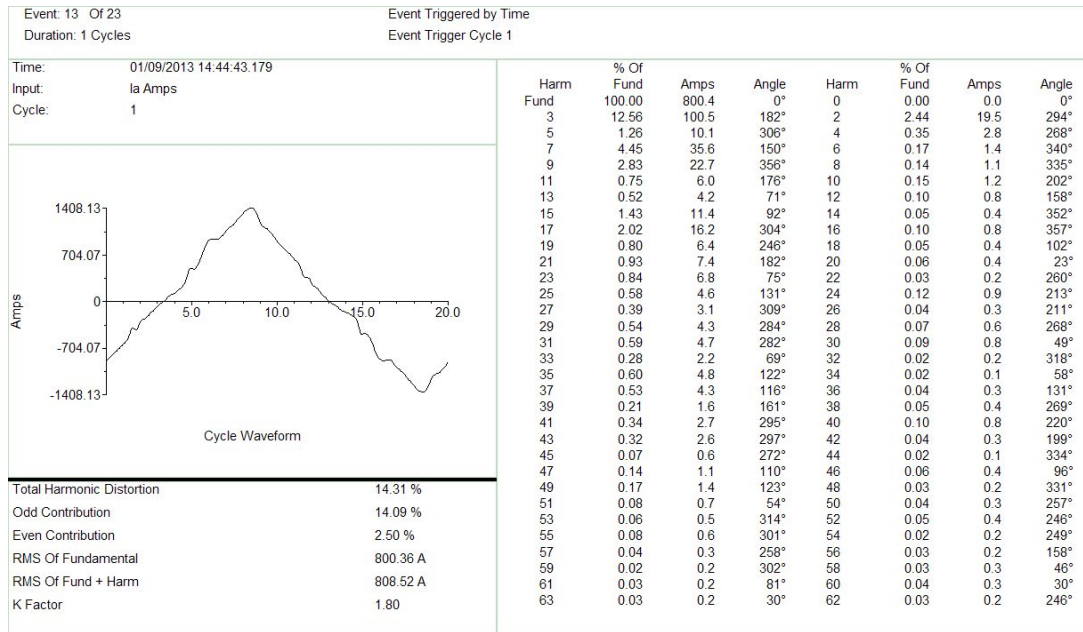
Fig.4: Harmonic Measurement

Harmonics is one of the possible causes of capacitor failures and fuse operations [2]. Measurements were performed to quantify the harmonic voltages and currents in the capacitors in order to study whether harmonics were the cause of the failures. Result of the harmonic measurement at full load of the company is shown in Fig.4

It can be seen that the network is switched into resonance with step 2, 3 and (or) 5 engaged. This is because the natural frequency of the network at these steps (hereafter referred to as resonant steps) coincides with 15th, 13th and 9th harmonic content of the network. Effect of the resonant steps on the capacitor bank was examined by simulation using the EMTP RV.

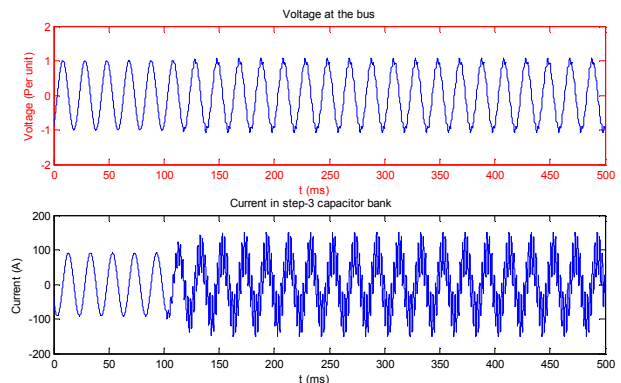
Fig.5: Voltage at bus-1 and current in step-3 capacitor bank

Harmonic current of 11.4, 4.2 and 22.7A associated with 15, 13 and 9th harmonic order were in turn injected into the network. Voltage at the LV bus and current drawn by the respective steps were observed. The worst resonance occurred at engagement of step-5. However, effect of the resonance was more pronounced in the step-3 capacitor bank. As can be seen in Fig 5, current amplification of about 170% of the normal current was observed in step-3 capacitor bank. This was about 160A drawn by step 3 capacitor bank: just equal to the size of the associated protecting fuse. IEEE standard 18-2002 allows 135% of capacitor nominal load but this is intended for contingencies and not intended for normal continuous load. From this stand point, it could be clearly seen that the magnitude of the current amplification is destructive.

It is important to note that normally fuse start fusing from 125 to 165% of it rated current [4]. Therefore, it was expected the 160A current limiting fuse of the capacitor bank should operate from 200 to 264A. This means the 160A fuse would not blow under the resonance condition. The capacitor will therefore, be expected to fail before the fuse blows.

Again, it is important to note that capacitor fuses are deliberately oversized to take care of capacitor switching transient and prevent excessive nuisance blow-outs [3]. Although the fuse may blow at certain resonance condition, capacitor fuses are not primarily sized to take care of resonance conditions. It is therefore important to measure and analyzed harmonic contents of an electrical installation and take preventive decision before installing a capacitor bank.

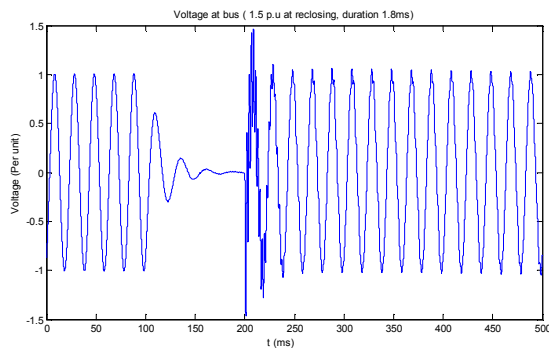
Fig.6: Overvoltage resulting from power restoration

Effect of power interruptions on the capacitor bank was examined. Overvoltage and inrush currents in the capacitor bank during restoration of power were studied. As can be seen in Fig.6, overvoltage induced from the power restoration was 1.5 per unit and this lasted for 1.8ms. IEEE standard 18-1992 and IEEE standard 1036-1992 allow overvoltage of 1.7 per unit for 1 second. It is obvious that the overvoltage induced by the power restoration was well within the standard safety limits and therefore, should have no effect on the capacitor bank.

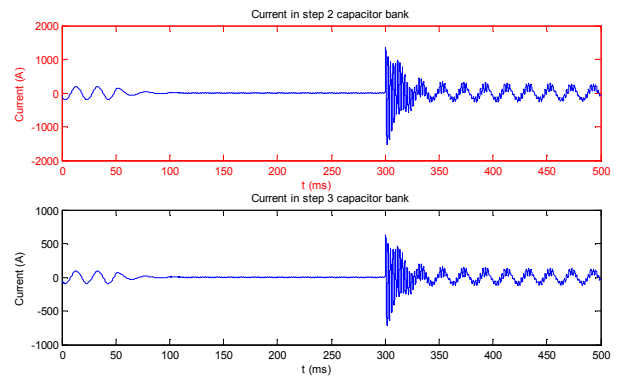
Fig.7: Inrush currents in the capacitor bank as a result of power restoration

Fig.7 shows inrush current drawn by step 2 and step 3 capacitor banks. Step 2 and step 3 give a representative result because they are made up of 112 and 56kvar respectively. Recall that each step in the bank is either 56kvar or 112kvar.

Inrush currents drawn by step 2 and step 3 capacitor banks were 1342A and 623A respectively. IEC 60871-1 standard establishes that the peak value of the overcurrent due to switching operations should be limited to a maximum of $100 \times I_N$ [5]. Where I_N is the rms value of nominal current. By this standard, the maximum inrush current limit for the 112kvar and 56kvar are 19600A and 9100A respectively. Consequently, it can be seen that the current drawn by the capacitors during the power restoration were far less compared with their maximum inrush current limits.
