Crack Formation Analysis of Return Air Flow Clamping in Air Conditioning using Finite Element Method

Abstract— In this study, crack formation during assembly and in service of injection molded return air flow clamping unit in the air conditioning system was carried out by using finite element method in couple with mechanical testing including tensile test and fatigue test to investigate the possible cause and ways to remedy such causes. It was found that high level of Von Misses stress closed to the yield strength value of the high impact polystyrene (HIPS) which was a raw material used was formed on the part while the fatigue strength of the specimen was also relatively low. Failure of the clamping unit of the return air flow was possibly caused by the excessive stress in the part which was a result of changing from the typical use of acrylonitrile-butadiene-styrene (ABS) to weaker and more brittle HIPS by the manufacturer. The design of the part should be reviewed to take into account this difference.

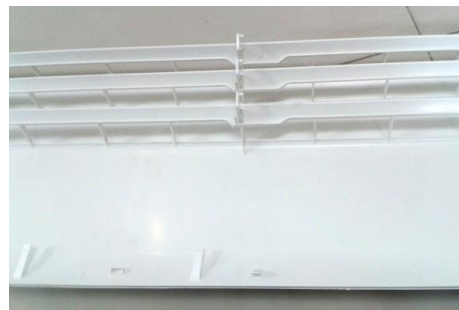
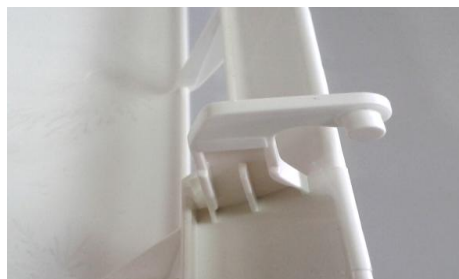
Fig. 1. Images of a) return air flow part and b) the clamping unit.

Today, engineering plastics have been used widely and increasingly in many industries for example electronics parts or household objects due to their distinguished features such as light weight, good processability and low cost [1]. The selection of plastics type and their properties are crucial since these could affect the quality and performance of the parts during services. In general, the failures that have been frequently encountered are excessive deformation and premature fracture prior to designed service life[1]. In this study, the failure analysis of the air conditioning's part called "return air flow" as shown in Fig. (1a) which is located at the front of the air conditioning indoor unit and used to control the direction of air flow into the room was carried out. This part contains several snap-type clamping units (Fig. 1b) used for assembling the part to

the main indoor unit. In the past, this part was made of acrylonitrile-butadiene-styrene (ABS) by injection moulding process, but recently was changed to high impact polystyrene (HIPS) due to the cost reduction policy. However, the occurrence of visible cracks in the clamping units during part assembly which consisted of bending the clamp out approximately 4.5-5.0 mm to snap into the counter holes was observed. Furthermore, several cracks also developed later during movement and vibration in services although the cracks were not observed during such assembly process. This resulted in the increase in numbers of defective parts that were needed to be replaced and claimed which raised the concern in quality of the manufacturer. Finite element analysis and mechanical testing including tensile test and fatigue test were thus carried out in this study to investigate the possible cause and ways to remedy such causes.

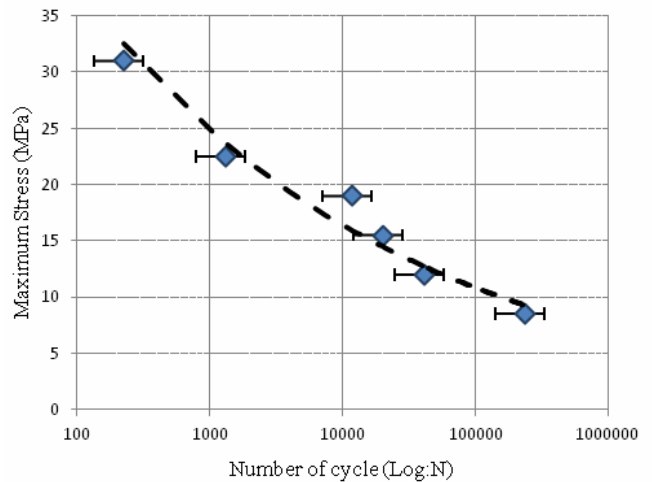
could be bended to just only 1.25 mm under the applied load of 4 N before exhibiting plastic deformation which could cause the damage. This was significantly lower than the bending distance of 4.5-5.0 mm as needed in the actual assembly process and might be the cause why the cracks were observed during assembly of the parts. These low values of bending may be also related to the low values of the elongation at break of the specimens as observed from tensile test. Fig. 7 shows the image of the damage part which contained crack caused by the assembly process. It could be obviously seen that the location of the crack corresponded well with the location of maximum Von Missess stress as seen in FEM analysis. Stress vs. Number of cycle to failure curve (S-N curve) of the specimens under tension-tension fatigue is shown in Fig. 8. No clear endurance limit was found even the stress was as low as 8.5 MPa and low number of cycle, 236,994 cycles, was obtained at this stress level. When subjecting to high level of stress

in the vicinity of yield strength as seen in FEM analysis, the cycles to failure of specimens decreased to only 223 cycles. This may correlate to the observation of in-service crack formation of the part even the cracks were not observed during assembly step.

Fig.8. Stress vs. Number of cycle to failure curve of HIPS specimens.
