Evaluating Contemporary Glazing Utilized in a new Tadao Ando-designed Private Museum

Daniel Joseph Whittaker

Abstract—The proper integration of the latest approved glass and insulated glazing unit (IGU) products for architectural use in precisely designed buildings is always a challenge. This paper examines the newest methods by which a recently opened private museum, built in Lincoln Park, Chicago, integrated tested and approved glazing materials inside and out, which provided aesthetically vetted solutions. Designed by Osaka, Japan based architect, Tadao Ando, and constructed using mostly American building products and American Union labor, Wrightwood 659 marks a serious achievement of integration of Western building technologies to provide a contemporary Eastern spatial experience. Architect Ando san, having completed a series of private and public museum designs across America, makes a serious leap forward in the use and advancement of new building technologies incorporated into Wrightwood 659. Several comparative case studies including former Ando projects such as the Pulitzer Arts Foundation building in Saint Louis Missouri (2001), provide compelling contrasts in glass and

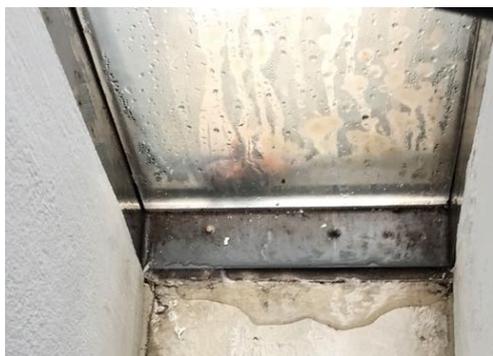
Fig. 1. Condensation upon narrow slit window at Pulitzer Arts Foundation, Observed February 2015.

First, the image shown in Fig. 1 is not simply an improperly installed window, leaking during a heavy rainstorm, which may be the assumption made upon first glance. Instead, what is occurring is internal building humidity, contained within the gallery rooms, disbursed in the air by the building's *properly* functioning HVAC equipment, is condensing on the cold glass *and* the cold aluminum window frames. Figure 1 conveys that such profuse amounts of water is condensing that it is flowing down the surface of the glass and surface of the frame and accumulating on the aluminum window sill, pooling out onto the concrete floor. As expected, adjacent gypsum board wall surfaces are also being affected, the porous wallboard covered with paper easily absorbs water and will subsequently discolor and swell producing gypsum crystal efflorescence.

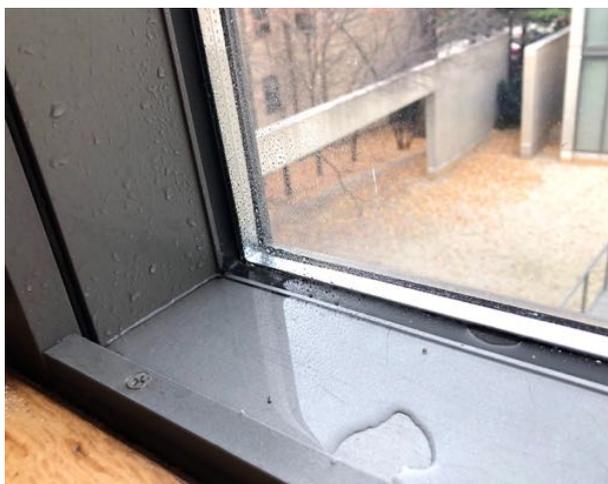
Fig. 3. Condensation upon non thermally broken aluminum sill of combination door and operable window, Wrightwood 665 Private Residence, Chicago, Observed Winter 2014.

above thermal performance conditions. Hence, while the entirety of aluminum frames composing the fixed windows in the residence (665 Wrightwood) possess thermal breaks and securely hold in fixed double-pane insulated glazing units (IGUs), the adjacent doors matching the fixed windows in appearance, are actually *not* thermally broken. As a consequence, during harsh winters, when there are a series of extremely cold days in Chicago, the same occurrence of a ‘thermal short circuit’ produces, just like at the Pulitzer building, excessive condensation on the door’s thin side stiles, head rail and bottom rail. Water substantially pools on the door sills. In spite of this functional failure, this was the best solution the various teams involved in the home’s design could produce, to simultaneously satisfy the design pro forma while subjugating thermal performance, in order to accomplish the primary goal: aesthetic performance in compliance with Ando’s design vision.

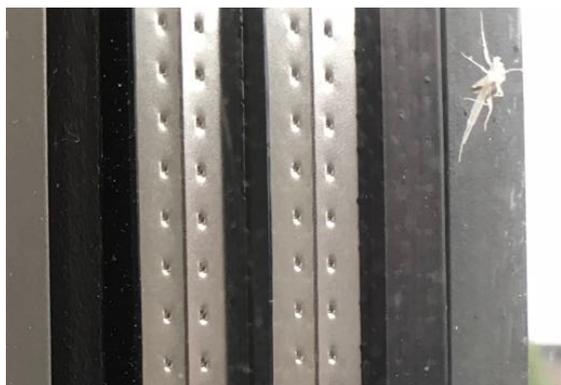
Fig. 5. The Clark Art Institute's IGU, zoom-in detail image.

As Fig. 5 illustrates, the triple-glazed IGUs at the Clarke possess the standard aluminum spacers, which are uniformly perforated like teeth on a zipper to allow any

excess moisture between the panes of glass to be absorbed into the desiccant crystals which are packed within the interior of the two bars separating the three sheets of glass. Translucent insect left in photograph indicates the rural nature of the Clarke, and what its large bodies of terraced water attract in outdoor Western Massachusetts.

While not a major aesthetic violation or compromise, the bright aluminum nonetheless is distracting to what otherwise is a rather dark color palette of black silicone window seals and Ando-gray painted aluminum mullions, indoors and out. What is hidden from view is the plastic resin thermal break, contained concealed within the aluminum window frame. The Chicago design team working on Wrightwood 659, observing nearly countless numbers of window assemblies and IGU configurations, went ahead with the design challenge and engaged window manufacturer Viracon to use one of their newest product enhancements, a material which covered the aluminum and made it visibly disappear from view by masking it in a minorly-reflective black coating. See Figure 6.

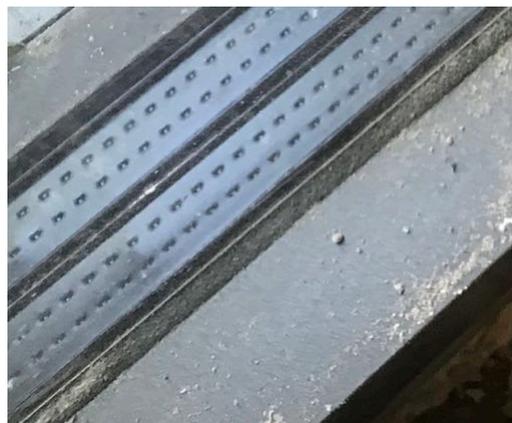
Fig. 6. Wrightwood 659: IGU window glass zoom-in detail, while site was dusty and under construction..

As figure 6 shows, the black coating still contains the necessary perforations to enable any stray moisture to be absorbed into the desiccant contained within, however gone are the harsh rays of reflected sunlight. The black

interlayer works in particular rather well in a triple-glazed configuration, to eliminate multiple unsightly distractions.

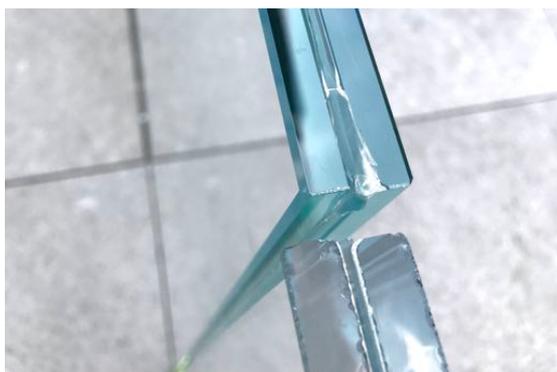
Fig. 8. Oldcastle low-iron glass, showing center PVB lamination.

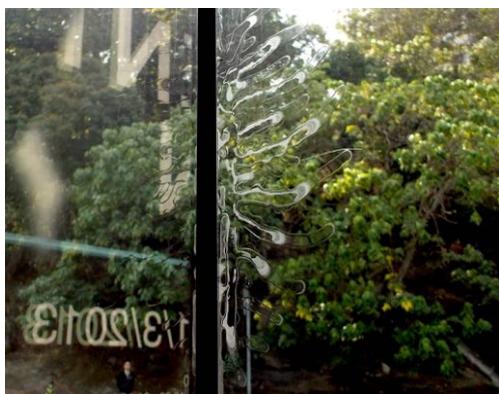
Fig. 9. Dendritic patterns of air intrusion in failed laminated glass panels. Asia Society building in Admiralty district, Hong Kong, S.A.R. China. Condition observed on site by author, 24 February, 2013.

interlayers can spoil a proper lamination job; examining Tod Williams and Billie Tsien's Asia Society building, constructed in the Admiralty neighborhood of Hong Kong, and opened on 9 February 2012 [8] demonstrates this. This building faced a plague of improperly laminated glazing panels. The intrusion of air between the two layers sandwiched together with a faulty PVB interlayer, is clearly visible as delamination creeps across the surface of the glass. Replacement is presented as the only operative solution; there does not technically exist a reliant on-site solution to 'fix' a tainted laminated glass failure, in situ.

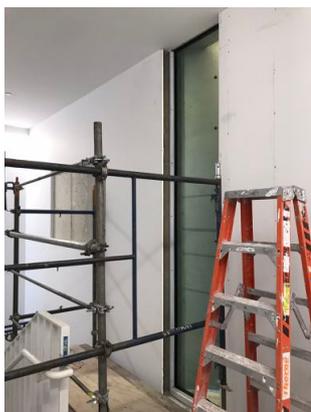
Fig. 11. Egress stair interior at northwest corner of core; view showing window placement at 'end' of concrete wall behind.

Although not anywhere as near as clear a Starphire glass, this product was better than any wired glass available. A recessed reveal was created in the concrete wall to accommodate the thickness of the IGU and also to hide the unsightly black sealing compound that is present in all IGUs, lining the perimeter of the unit.

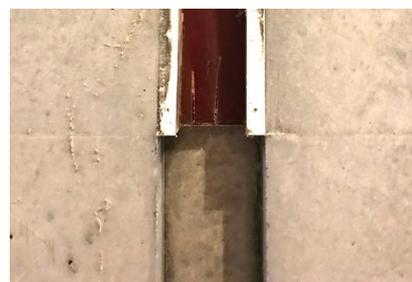
Fig. 13. Interior elevation of vertical embedded 'groove' in architectural finish Ando concrete wall; horizontal joint line subtly stretches across center of image. Dark maroon FinnForm formwork with white epoxy-adhered edge banding is visible; lower portion of formwork has been removed prior to taking this on-site photograph on 5 December 2017.

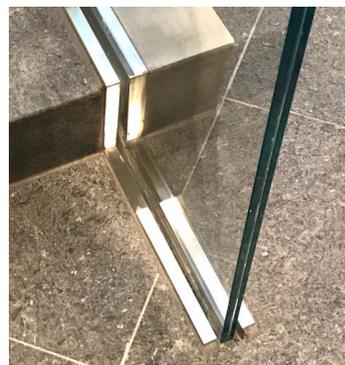
Fig. 16. First floor glass guardrail, as it starts, anchored into the lobby floor, prior to the first riser step rising up the angled monumental three-story staircase. Note the plastic laminate internal strip is visible.

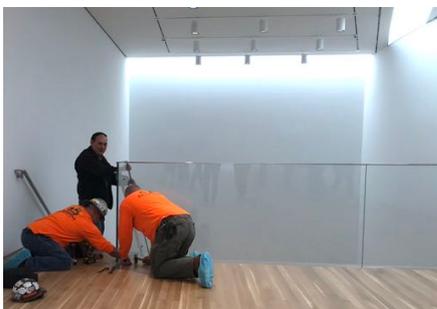
Fig. 17. Fourth floor gallery view south. Laborers are working at more securely anchoring the wedge slips stabilizing the glass guards.

Throughout the Ando building, the panels of glass composing the guards are *not* joined together. An air space gap, approximately 1/4” (6.35 mm) is present throughout the building. Other designers often times call for this gap to be caulked with clear silicone, which after application in reality is more translucent. Ando’s office specified that these gaps be minimized, and when absolutely technically necessary, to leave them open and un-caulked. This means that the occupant, when looking closely, can see the PVB interlayer edge laminating the two sheets of glass together. This edge is more apparent at 45° angled railing intersections. However, this reveal gap and laminated interlayer overall is quite negligible, while comprehending the spatial experiences of the gallery and its dynamic interior spaces.

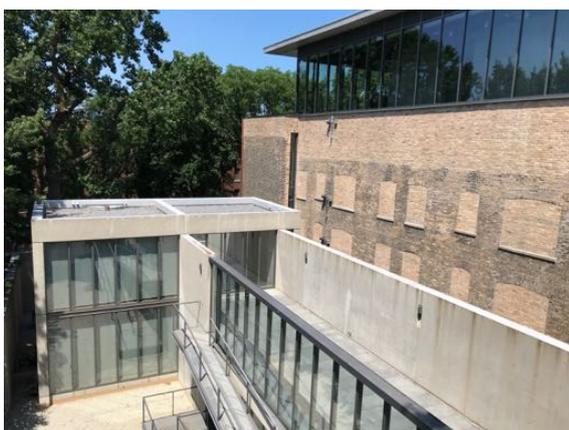
Fig. 18. Exterior view looking north, from roof of owner’s home towards northwest corner of Wrightwood 659 gallery building. Note filled-in window openings of former apartment building, along with new fourth-level of gallery building, being clad in floor-to-ceiling reflective glazing.
