# In Search of Electric Power Reliability in Forested Terrain with Covered Conductors: The ECG Experience

**Abstract-** A failure condition known as burndown and surface tracking of covered conductor insulating material appears to be restricting the widespread use of covered conductors in Ghana. The paper identifies specific problems militating against the use of covered conductors and reviews international experience on the subject with the aim of developing a performance system specification for covered conductor use in Ghana. The paper also discusses advances in protection methods for detecting downed covered conductors and recommends effective protection scheme that must go with the adoption of covered conductors.

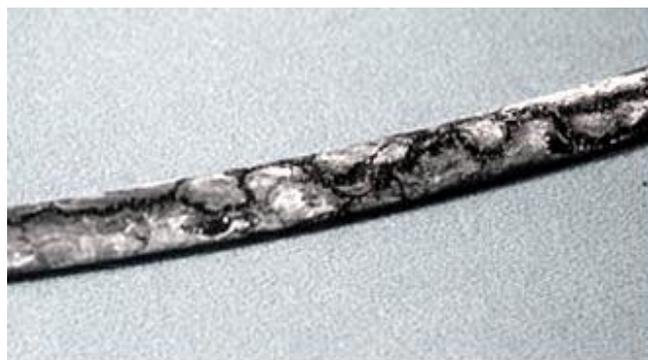
Fig.1: Surface tracking of conductor insulation.

In Ghana, the use of CC was introduced by the Electricity Company of Ghana (ECG) in the early 2010. The CC were deployed to replace existing bare conductors overhead lines in bamboos and forested terrains with the aim of improving supply reliability in these areas. Barely two years after its installation, monitoring and operational records have shown deterioration in supply reliability in areas where the CC have been installed. A failure condition known as burndown is being reported. Conductor burndown or fusion is said to occur when the conductor burns through or melt and falls to the ground [2][3]. Evidence obtained from actual burndown conductor, see Fig.1, indicates that partial discharges and surface leakage current may be contributing factors in causing the burndown.

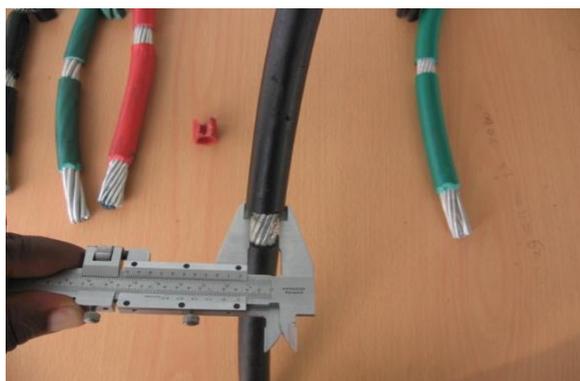
Samples of the CC were taken and their respective thickness measured as shown in Fig.2. It was found that the thickness ranged between 2.08 to 2.6mm. The measured values are shown in Table-2. The thickness was found to be in agreement with specification used for procuring them. The specification was mainly based on Australian/New Zealand (AS/NZS 3675) and IEC (IEC 60383) standards which state a minimum insulation thickness of 2mm. According to

Fig.2: CC samples and measuring of insulating thickness

Colour of CC		
	Green	Black	Red
At Cape Coast-Insulation thickness in mm	2.25	2.36	-
At Takoradi-Insulation thickness in mm	2.2	2.08	2.6

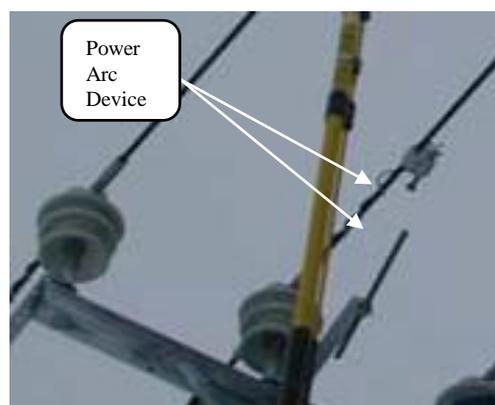
Fig.3: Power Arc Device

It is recommended that one lightning protection device should be installed on each pole and alternate among the phases of the power line (as shown in Fig.3), or three be installed on every third pole.

1. Semi-conductive tie and polymeric insulators should be used.
2. Every Day Stress (EDS) of the CC should be limited to  $28\text{N/mm}^2$
3. CC line should be constructed with lightning protection device. Either the Power Arc Device (PAD) or the Arc Protection Device (APD) should be used.
4. Since erection of CC lines require a specialized skill it is important that linesmen are given special training on CC erection.

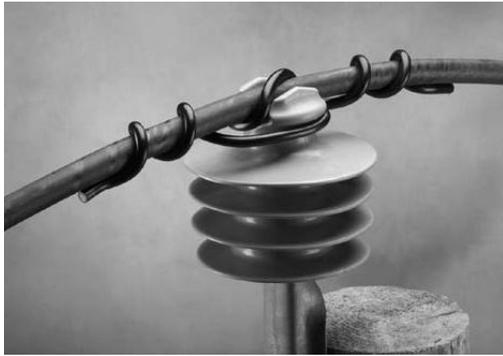
As discussed above, partial discharges and surface leakage currents at high electric-field points in insulator/tie region may be contributing factors to burndown.

Fig.4: Insulator/tie region

To determine which insulator and tie is most effective in preventing burndown, K. Nakamura et al [3] investigated the lightning impulse characteristics of eight different insulator and tie assemblies. The following were found:

1. Semi-conductive tie proved effective in preventing burndown.
2. Polymeric insulators, especially high-density polyethylene-based compound, reduce high electric field in the insulator/tie region.

In the case of porcelain and glass insulators, it was found that the electric field strength around the insulator/tie region presents high voltages on the conductor sheath surface which is believed to result in surface tracking.
