# Quality Indicators in Post-Disaster Housing: Case of the 2017 Coastal El Niño, Piura

Claudia C. Ramirez, Eduardo A. Sanchez, *Member IAENG*, Susana Vegas

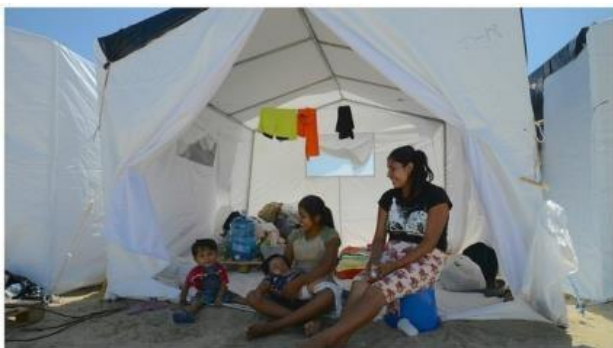
Fig.1. Damaged people resettled in temporary shelters days after the flood

The Instituto Nacional de Defensa Civil (National Institute of Civil Defense, or INDECI) was responsible for distributing multifamily tents in the most severely affected areas (Fig. 1). Most of the tents were set up in the camps located at Kilometer Markers 975 and 980 of the North Carretera Panamericana Highway, to which the majority of refugees from Pedregal, La Campiña, and Cura Mori were evacuated. These tents had a capacity of 5 persons, with an umbrella-type roof, one door, and three windows. Due to the high temperatures registered in the area, however, it became unbearable to stay in the tents during the day, while water from the constant rainfall leaked in through the tent roofs at night. As a result, the tents were considered low-quality.

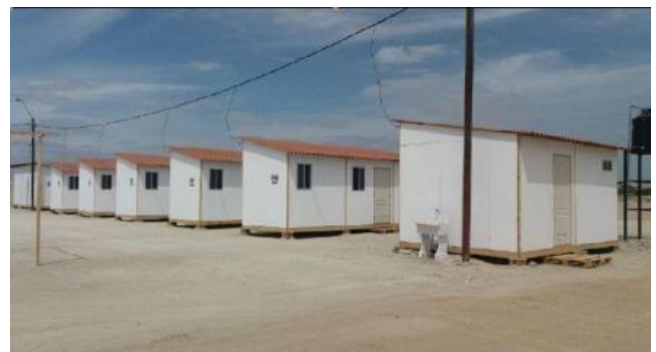
Fig. 2. Initial Housing Unit

In the Piura region, INDECI provided 6,500 temporary housing units, known by the name of Unidad de Vivienda Inicial (Initial Housing Unit, or UVI) (Fig. 2). These modules measure twenty square feet, with wooden walls and floors, fiber cement lining, and five windows [14]. Of that total, 3,000 housing units were sent to the San Pablo, San Pedro, and Santa Rosa camps, while the remaining housing units were located at the most severely affected points of the city. According to Edmer Trujillo, the Minister of Housing, Construction, and Sanitation of Peru, the delivery of the UVIs was an intermediate step prior to the definitive construction of post-disaster housing [15]. This step was expected to make substantial improvements to the living conditions of the disaster victims, who had been residing in temporary shelters (tents) up to that point.

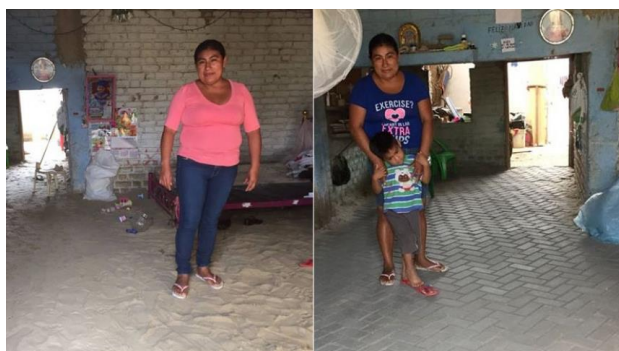
Fig. 3. Differences between dirt floor and cement floor following the *Firm Ground* project.

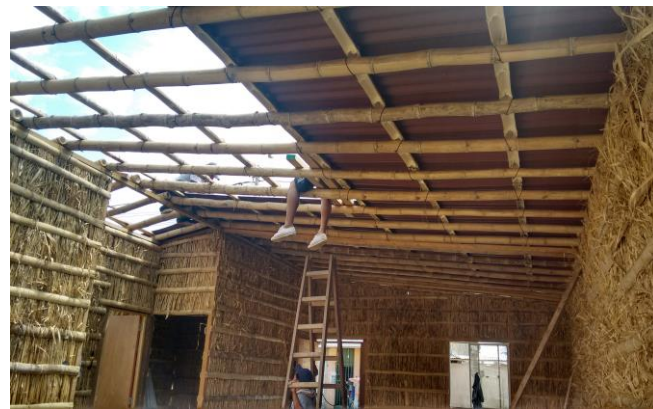
Fig. 4. Implementation of the post-disaster housing roof.

--Pitched roofs were selected for weatherproof, post-disaster housing, due to the constant rains in the area. *Tornillo* wood was used for the roof structure, with whole bamboo canes and Fibraforte sheeting for the covering (Fig. 4).

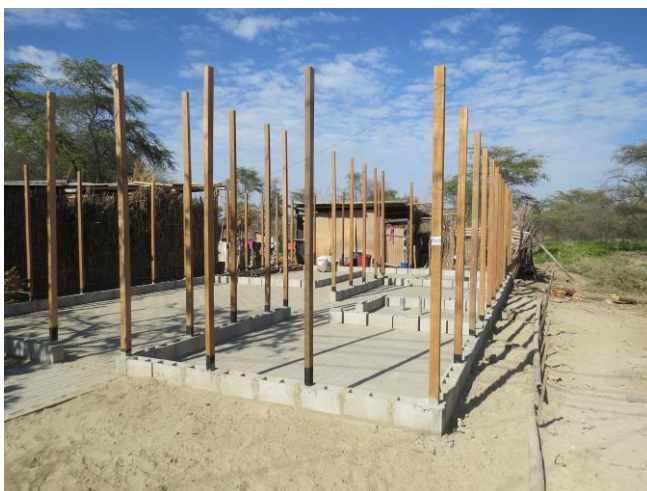
Fig. 8. Solid Structure of the house base.

--Structural soundness: Concrete blocks were installed to replace the bases. The wood of the structure is twice as deep, and walls were reinforced with Guayaquil cane to provide the house with greater rigidity (Fig. 8).

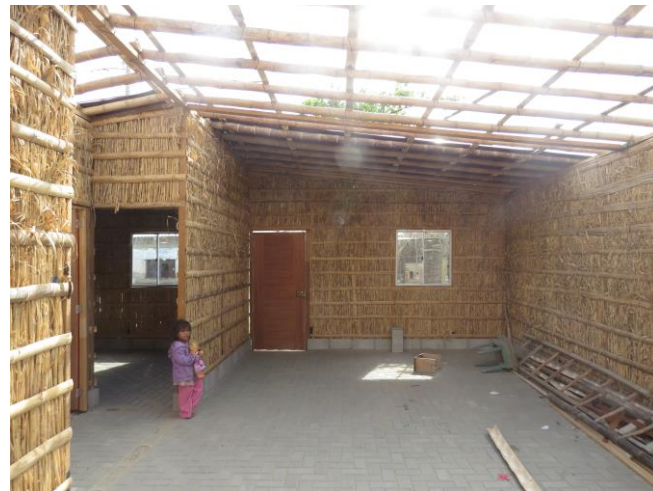
Fig. 5. The ventilation of the house is due to the roofs high and walls material.

--Ventilation and temperature: The height of roofs and the material used in the walls (reeds) of the house helps to facilitate ventilation of the home and, most importantly, to moderate the high temperatures typical experienced in Piura (Fig. 5).

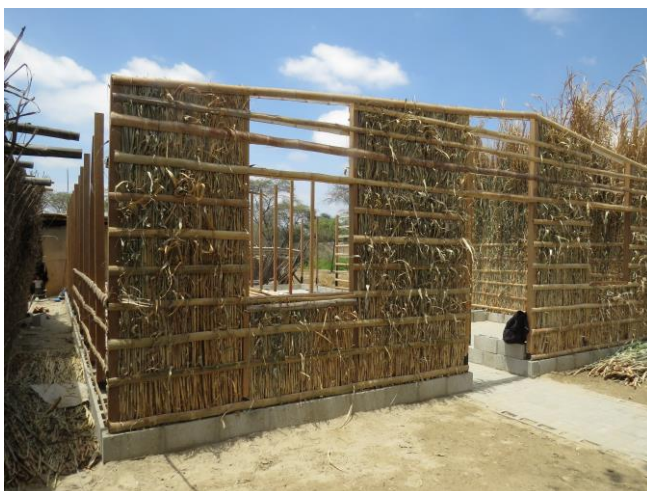
Fig. 7. Materials of the house.

--Safety and security: The structure of the house is made of reeds, bamboo canes and *tornillo* wood. Each room in the house has a door and lock, providing peace of mind for the occupants (Fig. 7).

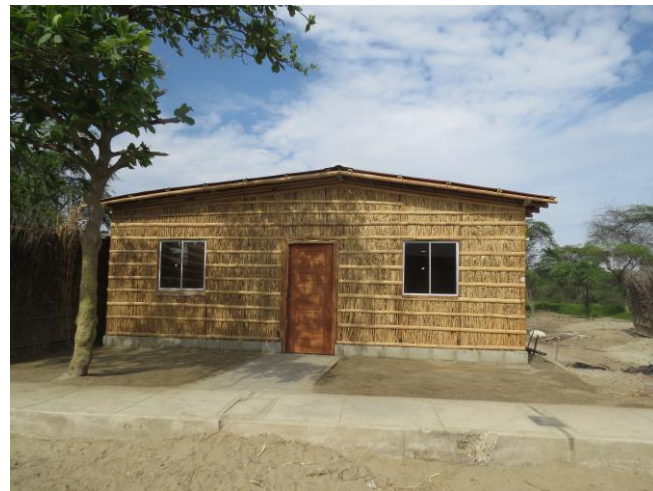
Fig. 9. Final Result of the post-disaster housing

--Choice of materials: Materials from the area such as reed, Guayaquil cane, *tornillo* wood and sand were used because of their accessibility and ease of transportation (Fig. 9).
