# Warm Hydrocarbon Gas Flare Burners - Corrosion Analysis

P. N. Atamuo, *Member IAENG*, Gbasouzor Austin Ikechukwu, *Member IAENG*, G. M. Onyegbuchule and A. U. Iwuoha

**Abstract** – In Nigeria Oil/Gas industry, crude oil receiving stations have with them gas flaring facility to burn away the associated gas which follows the crude oil to the stations. Some of these gas flaring facilities are fabricated with stainless steel (SS), typically of the 400 series which from experience have yielded to corrosion earlier than calculated/estimated. Replacements with unscheduled costs have been made on these burners that failed due to scaling, flaking, pitting, material loss and smoking. A study is made here of the resistance of other grades of AISI SSs to determine their resistance to the corrosive flare environment and hence their effectiveness as burners in the flare stack for longer service life, thus minimize costs by lengthening the replacement time and prevent production shut-ins. In this service domain, the grades of SSs with higher quantities of chromium, nickel and silicon produced in the cast state as against the wrought state showed higher corrosion resistance and service stabili

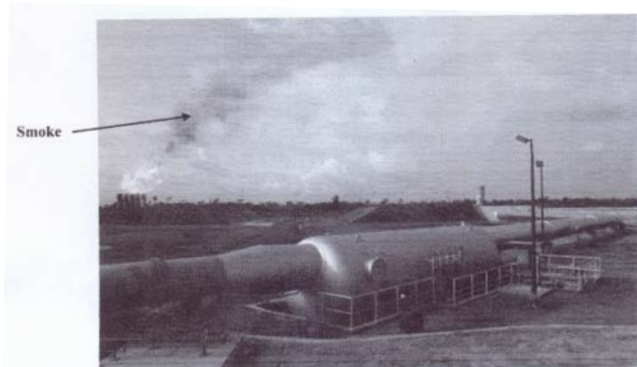
Fig. 1: Flare stack operating with corroded burners

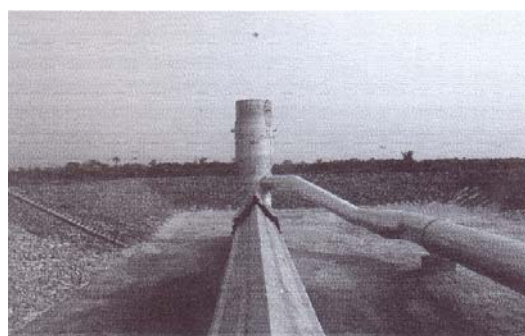
Fig. 3: Flare Stack with AISI 446 SS Burner ready for Service.

Based on the results of the analysis, the following materials were recommended for the flare burners: **Material A:** AISI Type 312 SS; **Material B:** AISI Type 347 SS and **Material C:** AISI Type 446 SS. The recommendations were implemented. Replacement flare burners were produced with the recommended materials and were installed/put to use. The actual elemental composition of these grades of steel used for the production of the new replacement burners are listed in Table below alongside their AISI standards. Table VII lists the new burners service data after installation and use.

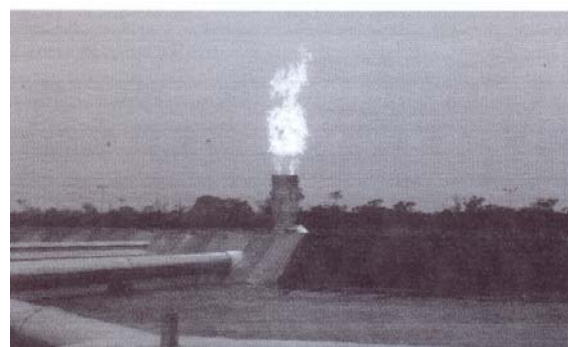
Fig. 4: Flare Stack with AISI 347 SS Burner in Service.
