# An Investigation into Protection Integrity of Distribution Transformers - A Case Study

**Abstract**—This paper investigates protection integrity of distribution transformers in Ghana. The purpose of the study was to find the main causes of distribution transformer failures in Ghana. The study was conducted in the Ashanti East Region, one of the operational areas of Electricity Company of Ghana ECG with high incidence of distribution transformer burnouts. Data on status of protection systems on 676 distribution transformer stations were taken and analyzed. It was found that protection integrity at distribution substation is riddled by indiscriminate use of copper links to replace blown HRC fuses and high ground resistance. The study clarifies why distribution transformers with lower power ratings are more vulnerable to abuse of protection systems than distribution transformers with higher rated powers. The paper reports on the investigation and proposes alternative solutions in mitigating the problem. Although the background work of the study is restricted to Ghana, the applicability and importance of the work would be useful to the scientific community.

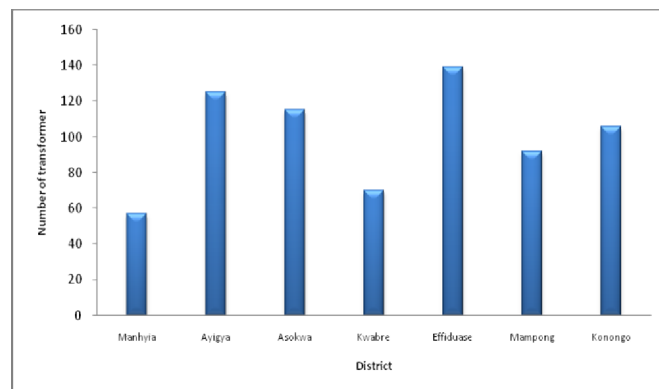
Fig-1 shows population of distribution transformers in the Ashanti East Region represented by its districts. It is observed in Fig-2 that transformer failure rate in the region is assuming an exponential function. From Fig-2, twenty five transformers would be expected to fail in the 6<sup>th</sup> year if the status quo is maintained. Where 1, 2, 3, 4, 5 and 6 on the x-axis in Fig-2 represent year 2007, 2008, 2009, 2010, 2011 and 2012 respectively. Fig-3 shows the district's contribution to the failure rate. It is observed that Manhyia, Asokwa and Konongo are relatively low in terms transformer failures. However, it was noted from Fig-4, that Manhyia, Ayigya and Asokwa were districts with high population of transformers

Fig-1: Distribution of transformers in the Ashanti East Region

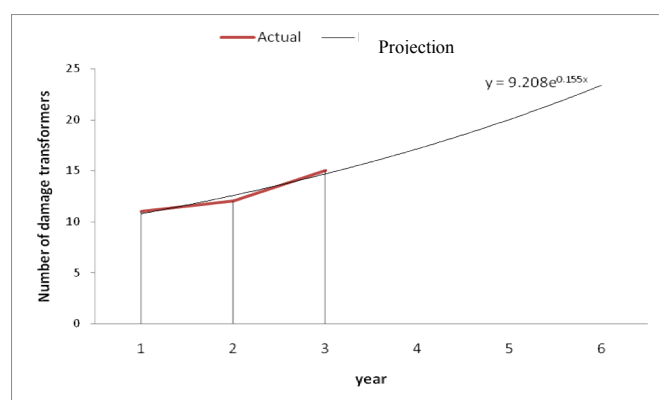
Fig-2: Trend of transformer failures in the Ashanti East Region

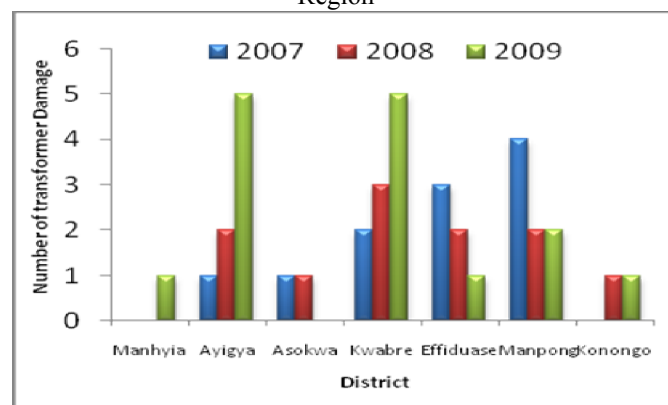
Fig-3: Number transformer failure in the districts

Fig-9 shows percentage of distribution transformers in the districts with lightning arrester ground resistance greater than 10-ohms. There appears to be a strong relationship between high arrester ground resistance and number of transformer damages in the districts, see Fig-3. This gave an indication that the higher the ground resistance values, the more the failures. It is noted from the preceding discussion that the failures are prevalent among the 50, 100 and 200kVA transformers. These transformers are mostly Pole Mounted Transformers [PMTs]. As high arrester ground resistance impinges on lightning protection integrity, it is our belief that the cause of the failures may also be attributed to lightning surges. Unlike Ground Mounted Transformers [GMTs] which are fed from cable with some degree of surge attenuation

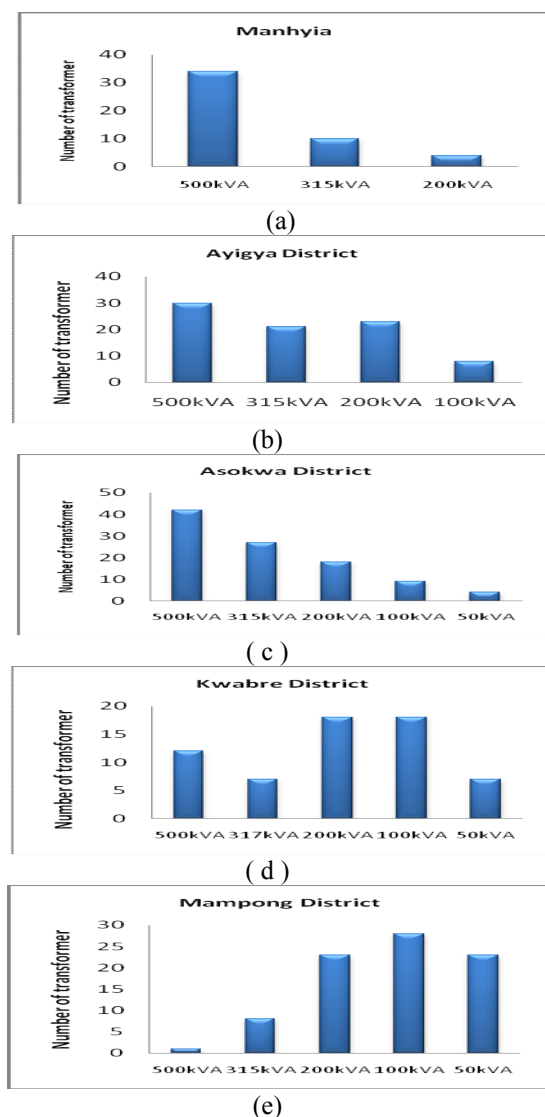
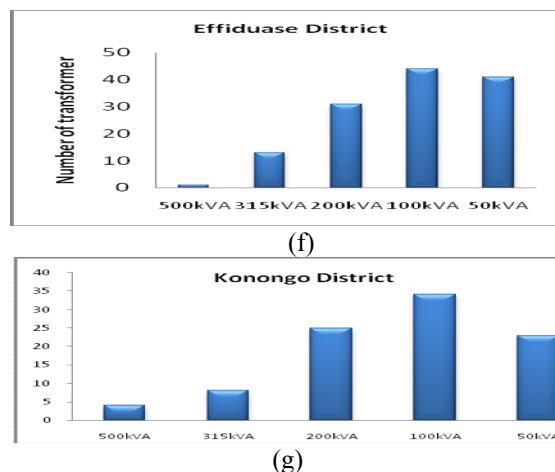
To explain this phenomenon, population of transformers in the respective district in relation to power ratings was examined; this is shown in Fig-5. A profile of damage transformers relative to transformer capacities was also examined, see Fig-6. From Fig-6 it was observed that the failures were common among 50, 100 and 200kVA transformers. From this standpoint, one may be tempted to draw a conclusion that these transformers might have some inherent deficiencies. Our investigation pointed to over fusing resulting from the use of the copper links. The size of copper links used as fuses in all the district were the same: a double of 4mm<sup>2</sup> (8mm<sup>2</sup>) copper link were used irrespective of transformer capacities, see Fig-7. Using the relation given below for determining appropriate wire size for fusing [7], it was found that whereas the copper link may be considered safe for a 500kVA transformer (on its low voltage side), it could represent an over fusing for 50, 100, and 200kVA transformers based on the associated distribution board used and number of out-going feeders fused with the copper links.

Fig-5: Population of transformer in relation to power ratings: (a) Manhya (b) Ayigya (c) Asokwa (d) Kwabre (e) Mampong (f) Effiduase (g) Konongo

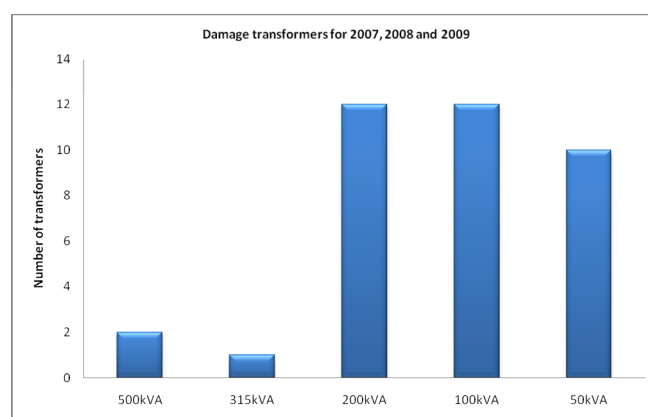
Fig-6: A profile of damage transformers in relation to transformer capacities

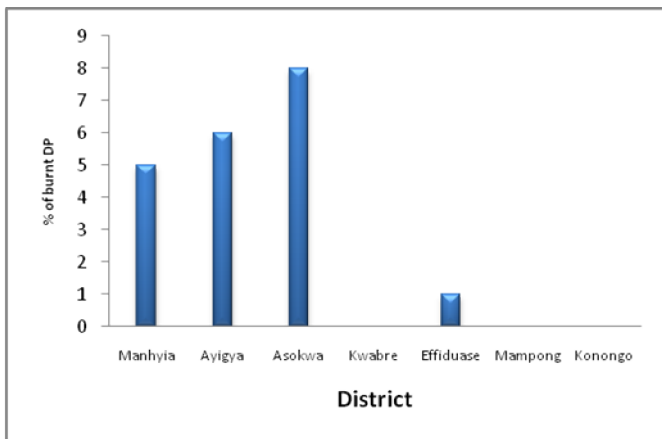
The effect of the copper links was rather seen on the distribution pillars, see Fig-7. Districts with high incidence of LV copper links as fuses recorded high incidence of DP burnouts- the links were directly hooked to fuse contacts in the DPs. As a result, the DPs and their associated instruments were exposed to naked fire of the copper links during fusing. Mampong was also high on copper links but with no DP burnout because wedge type fuses (aerial fuses) were predominately used in the district.

Fig-8: Number of Distribution Pillar Burnout

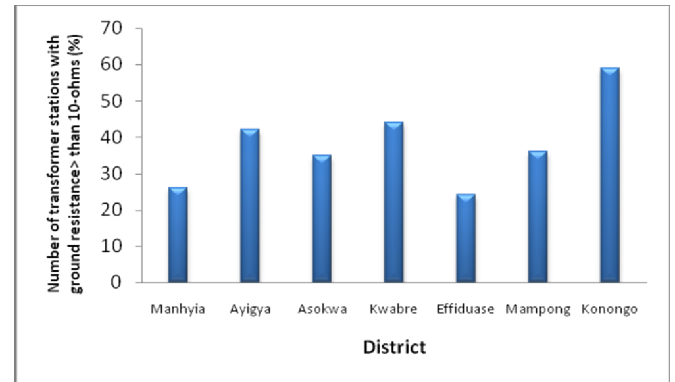
Fig-9: Transformers with lightning arrester ground resistance greater than 10-ohms

From the data collected and followed by field periodic monitoring, it was observed that ground resistance values varied in order of 200% over a year. In our previous study [10], Palm Kernel Oil Cake [PKOC] was identified as an alternative to ground resistance-reducing agent. The PKOC has shown to offer significant reduction and stabilize ground resistance values over the years. The PKOC is applied using the critical resistance area concept [11]. Although our study of the PKOC on lightning protection performance on distribution transformer is yet to be complete, operational records in high isokeraunic areas so far indicate reduction in transformer failure in areas where PKOC have been applied. It is therefore our proposal that the PKOC is used to improve ground resistance values in areas where lightning arresters' ground resistance is high.
