Potential Risks of CCA-Treated Wood Destined to Landfills

Emmanuel Emem-Obong Agbenyeku, Edison Muzenda and Innocent Mandla Msibi

Abstract—In recent years, recycling has become the first best option of dealing with waste before landfilling is considered in cases of handling difficulties. In South Africa however, 41,000 tons of solid waste is destined for landfills daily; which includes huge chunks of waste from construction and demolition activities. The continued reliance of South Africa on the landfilling system could extend a while until economical recycling alternatives are introduced. Leachate generation and percolation is expected in these landfills on account of infiltration of water into the waste body from rain and/or runoffs. Although, it has been documented that arsenic, copper and chromium percolate soil systems, it however noted that occurring physical, chemical and biological activities may influence mobility of metals from generated leachate. This is particularly evident in cases where Chromated Copper Arsenate (CCA)-treated wood are disposed in monofills with consequential impacts on the environment. Laboratory investigation using a bespoke device to explore the e

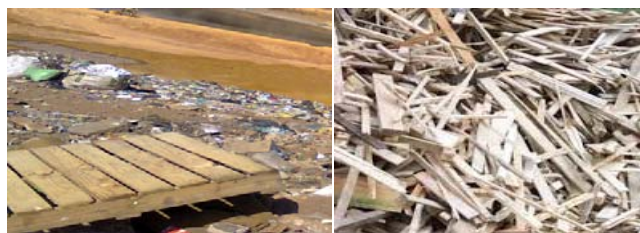
The CCA-treated wood was sampled in arm length and broken pieces from a disposal site slightly distant from heaps of other domestic solid waste in Johannesburg, South Africa as seen in Fig. 1a and b. This was used as the waste body since the study herein sought to generate leachate from the deposition of CCA-treated wood by using a laboratory bespoke column device to simulate a monofill. A small scale bespoke device about 600mm long with internal diameter of about 160mm was used in the study.

(a) Landfill area (b) CCA-treated wood waste
 Fig. 1. (a) and (b) Sampling site of CCA-treated wood waste

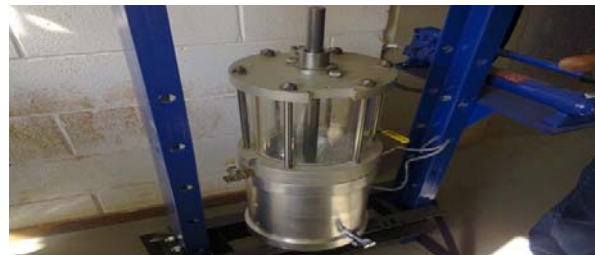
A pictorial view of the laboratory bespoke device is shown in Fig. 2. For the purpose of this study, the device was coupled to comprise of two sections:

1) the bottom part called the bucket section; which contained the CCA-treated wood to a height of 230mm, simulated the waste in a monofill. The sampled CCA-treated wood waste was chopped into smaller particle sizes so as to fit into the small scale bespoke apparatus. Selected gravel was laid as drainage path in the bucket section and a wet geotextile

was placed over it to prevent clogging of the outlet by moving fines which served as the filter bed in the system.

Fig. 2. Bespoke test device

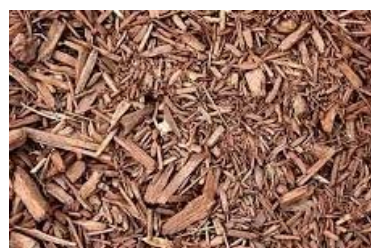
While Fig. 4 and Fig. 5a and b shows the chopped CCA-treated wood and the experimental arrangement for the bucket containing the CCA-treated wood respectively.

Fig. 4. CCA-treated wood chopped into smaller pieces for percolation tests

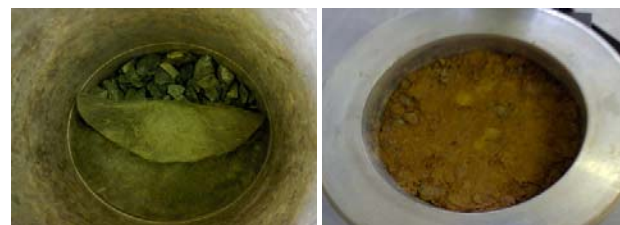
(a) Filter bed (b) Soil over CCA-treated wood
 Fig. 5. (a) and (b) Wet geotextile placed over selected gravel and lightly compacted clayey soil over chopped CCA-treated wood in the bucket section

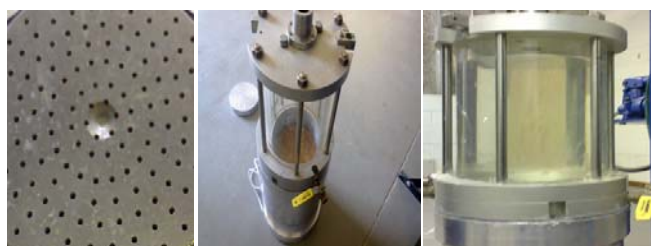
2) the upper part above the bucket section called the reservoir; contained de-ionized water as influent which flowed

through a perforated plate into the bucket section (waste body) simulating low intensity rain droplets slowly saturating the waste body till leachate was formed and the concentration of the collected effluent was tested at intervals to monitor the concentration levels of the targeted chemical ions. The system was coupled firmly using O-rings, gasket corks and silicon sealants to ensure a leakage free assembly. The reservoir held a water head of 250mm which was manually topped as the water level dropped since a mechanism for retaining constant head was not designed for in the device. Fig. 6a and b show the upper section of assembled device for the experimental study carried out.

Fig. 6. (a) and (b) Perforated plate through which de-ionized water as influent in the reservoir section flowed simulating low intensity rain droplets

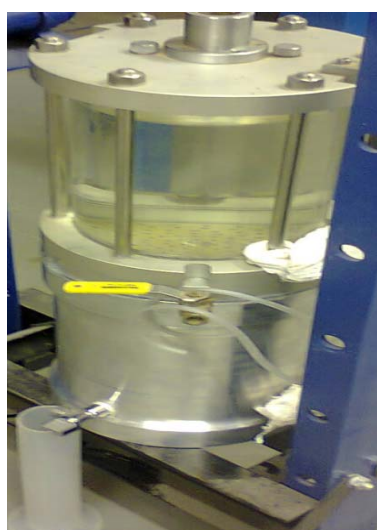
In this study, the choice of CCA-treated wood monofill offers the worst-case disposal scenario in unlined sites considering that the disposal of chemical treated wood will in a long time to come be continually dumped. This case will also aid a clearer understanding on the chemical ions generated thereof without intrusion from contaminant species of other sources. As such, outside other confirmatory percolation tests conducted in the study, two main tests where considered and recorded. Test-A represented the experimental case for simulated CCA-treated wood in a monofill while Test-B represented the control case with untreated wood. The fully assembled percolation test setup studied herein is shown in Fig. 7.

Fig. 7. Percolation test under study using de-ionized water as permeant for CCA-treated wood with the effluent collected and tested at intervals to track the concentration levels of the targeted chemical ions of concern

The tests were conducted in room temperature with respective tests lasting up to 15days. On the formation and breakthrough of leachate, a 50ml cylinder was used to constantly collect the effluent. Although, general water quality parameters i.e., pH, dissolved oxygen (DO), conductivity, temperature and oxidation-reduction potential (ORP) were measured in the study using a Portable Multi-flex Beckman Century pH/mV/FT/DO-915A-1202-TM SS-1 Meter Model, however, only pH was discussed as other parameters require validation. Collected leachate were put in plastic containers and stored in a cooling chamber at 2°C to prevent any form of chemical or biological activities. The effluent samples were then analyzed by full spectral method and were compared to South African standard of drinking water in conformance with [10].
